# Manhole Inspection Summary

Manhole # S33M\_\_033MH

Insp Date: **9/16/08 11:44 AM**

**Location** Address: **w lee st**

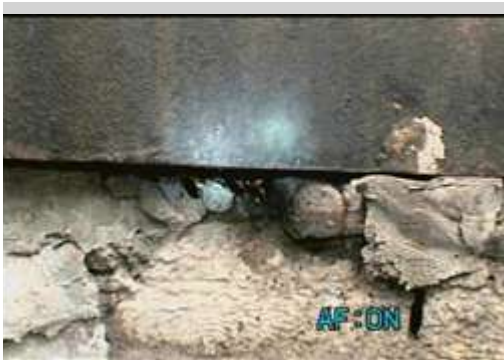
Defect 2

**Chimney / Frame Adjustment** ☒ Exists Material: **Brick and Concrete** ☐ Parged Height: **6** (in.)  
Condition: ☐ Sound ☒ **Cracked** ☐ Root Intrusion ☒ **Loose Brick** ☒ **Deteriorated**  
Infiltration: ☒ None ☐ Joint ☐ Cracks ☐ Mortar ☐ Roots ☐ Wall

cracked, loose bricks, deteriorated, frame adj

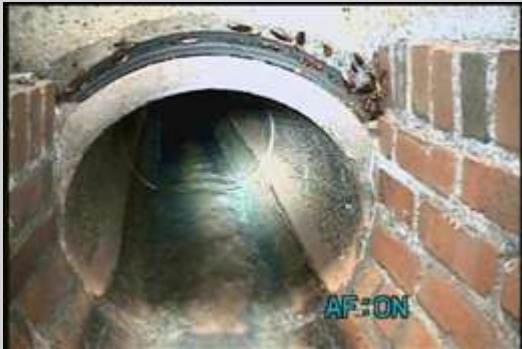
12 O'Clock Outflow

18 in. Circular Gravity Sewer  
Pipe Out @ 12 O'Clock

Invert Depth: **9.90** (ft.) Flow Characteristics: **Fast**

Infiltration: **None** Pipe Seal Cond: **Unknown**

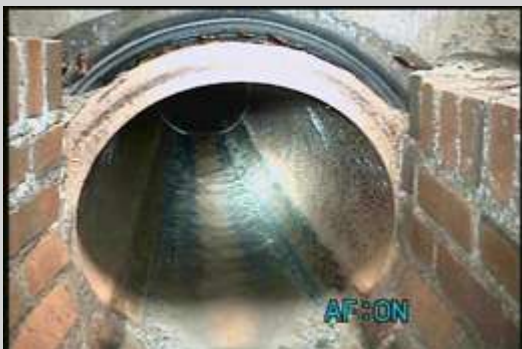
6 O'Clock Inflow

18 in. Circular Gravity Sewer  
Pipe In @ 6 O'Clock

Invert Depth: **9.80** (ft.) Flow Characteristics: **Fast**

Infiltration: **None** Pipe Seal Cond: **Unknown**
